**HYDROLOGY STUDY OF  
SALT SLOUGH, MERCED COUNTY**

**California Regional Water Quality Control Board  
Central Valley Region  
3443 Routier Road  
Sacramento, California 95827-3098**

**February 1989**

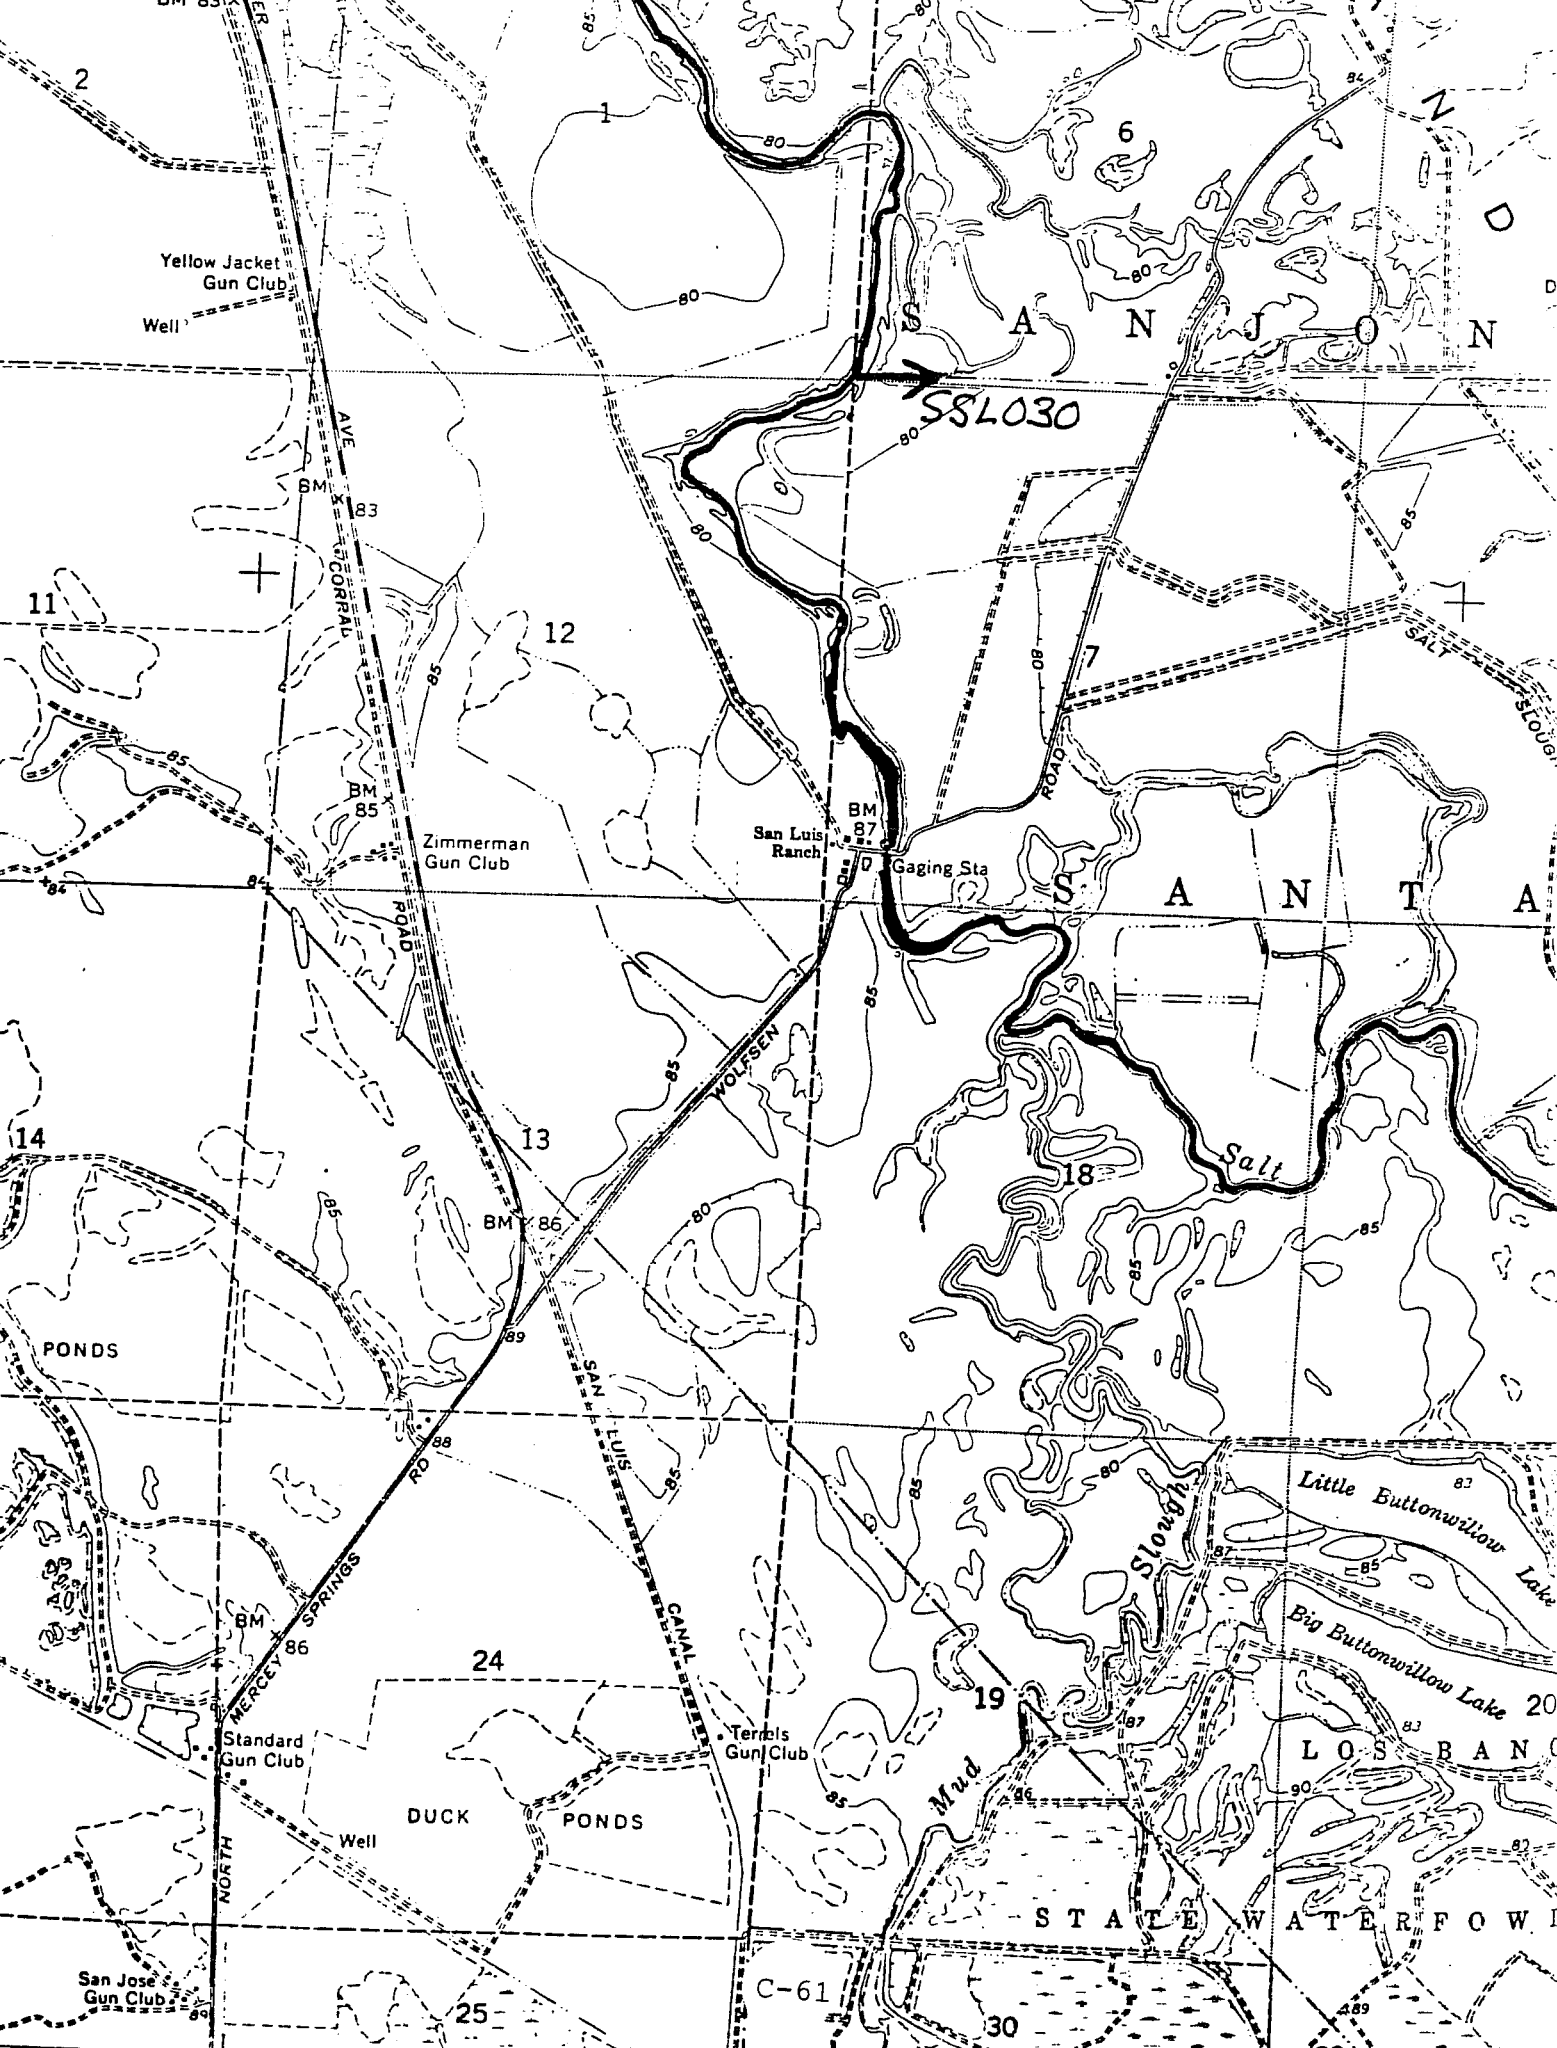
**SITE ID #SSL030**

**Site description, location, and access:** From Los Banos take Mercy Springs Road north for approximately 6.5 miles to Wolfson Road. Proceed northeast on Wolfson Road for approximately 2.1 miles to the entrance of the San Luis National Wildlife Refuge. At this point, you will have just passed over a large canal. Follow this canal west along the north side to Salt Slough. At the Slough, two large pumps (with yellow motors) lift water from the Slough into the canal. This is the diversion site.

**Type of diversion and use of the water:** Water at this point is lifted from the Slough by two large pumps. It is used to flood duck ponds in the San Luis Wildlife Refuge. The quantity of water diverted at this point is 40.9 cfs.

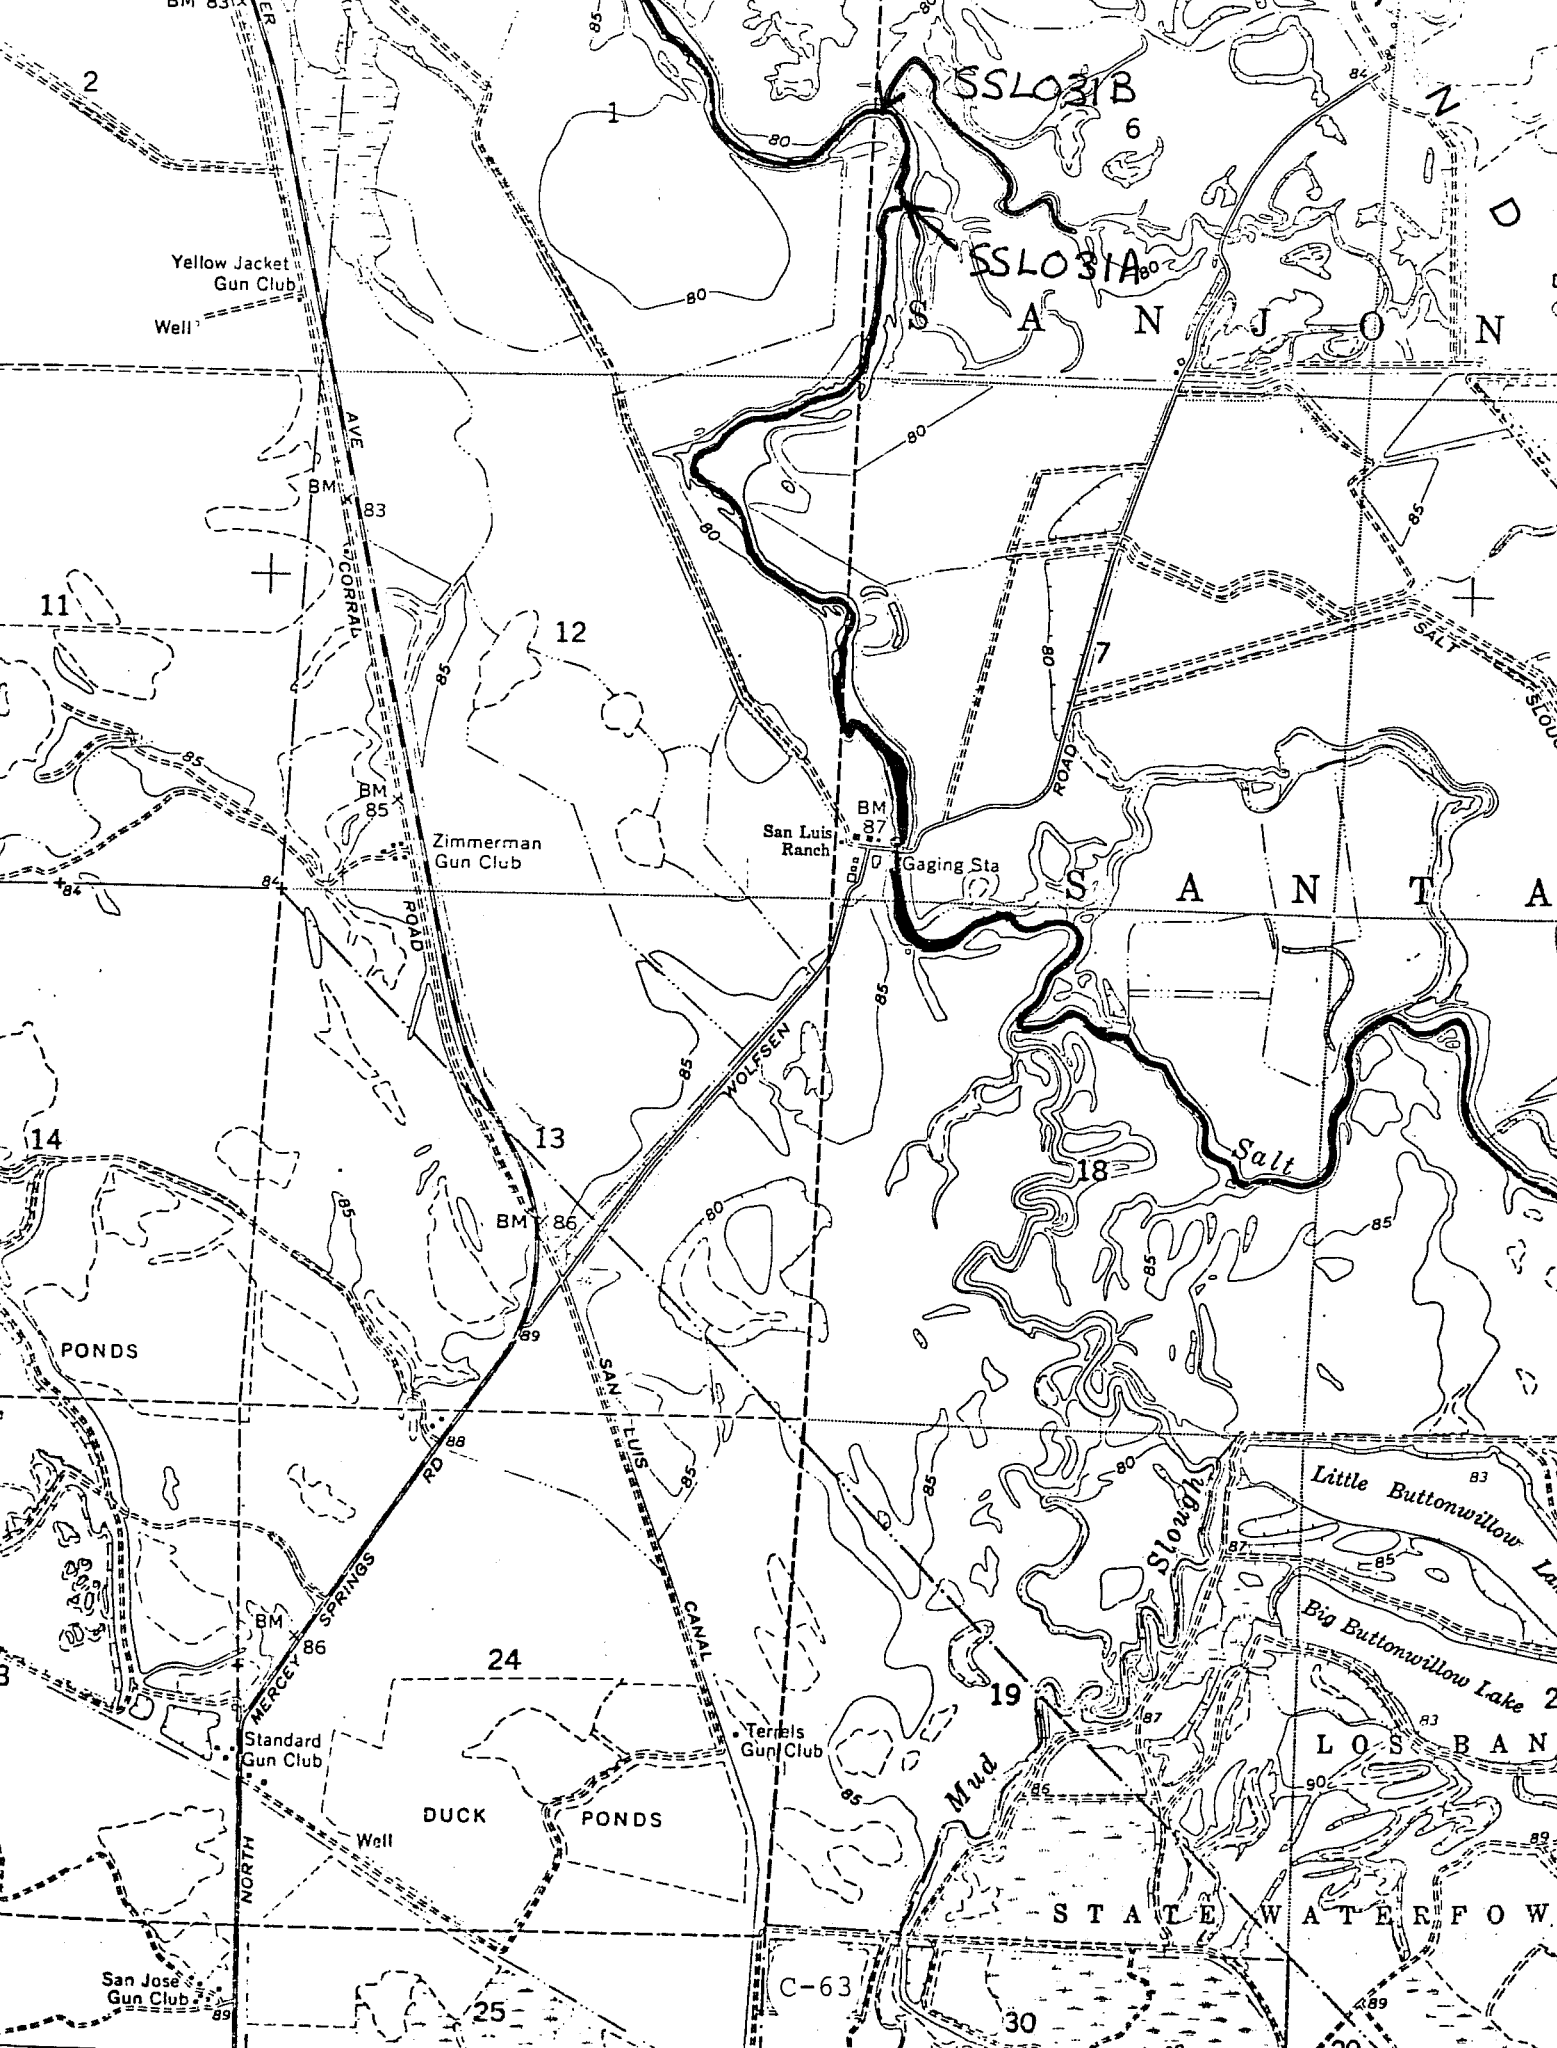
SITE ID #SSL031A-B

**Site description, location, and access:** From Los Banos take Mercy Springs Road north for approximately 6.5 miles to Wolfsen Road. Proceed northeast on Wolfsen Road for approximately 2.1 miles to the entrance of the San Luis National Wildlife Refuge. At this point, you will have just passed over a large canal. Follow this canal west, along the north side, to Salt Slough. From here, proceed north for 0.8 miles to where a small channel undercrosses the road. This is site SSL031A.

**Type and source of water being discharged (description):** Both drains drain small areas of the San Luis National Wildlife Refuge just to the east of Salt Slough.

<u>Site #</u>	<u>Slough Mileage</u>	<u>Site Description</u>
SSL031A	6.66E	Small channel undercrosses levee road in corrugated pipe.
SSL031B	6.91N	Small channel undercrosses levee road in corrugated pipe 0.25 miles north of SSL031A.

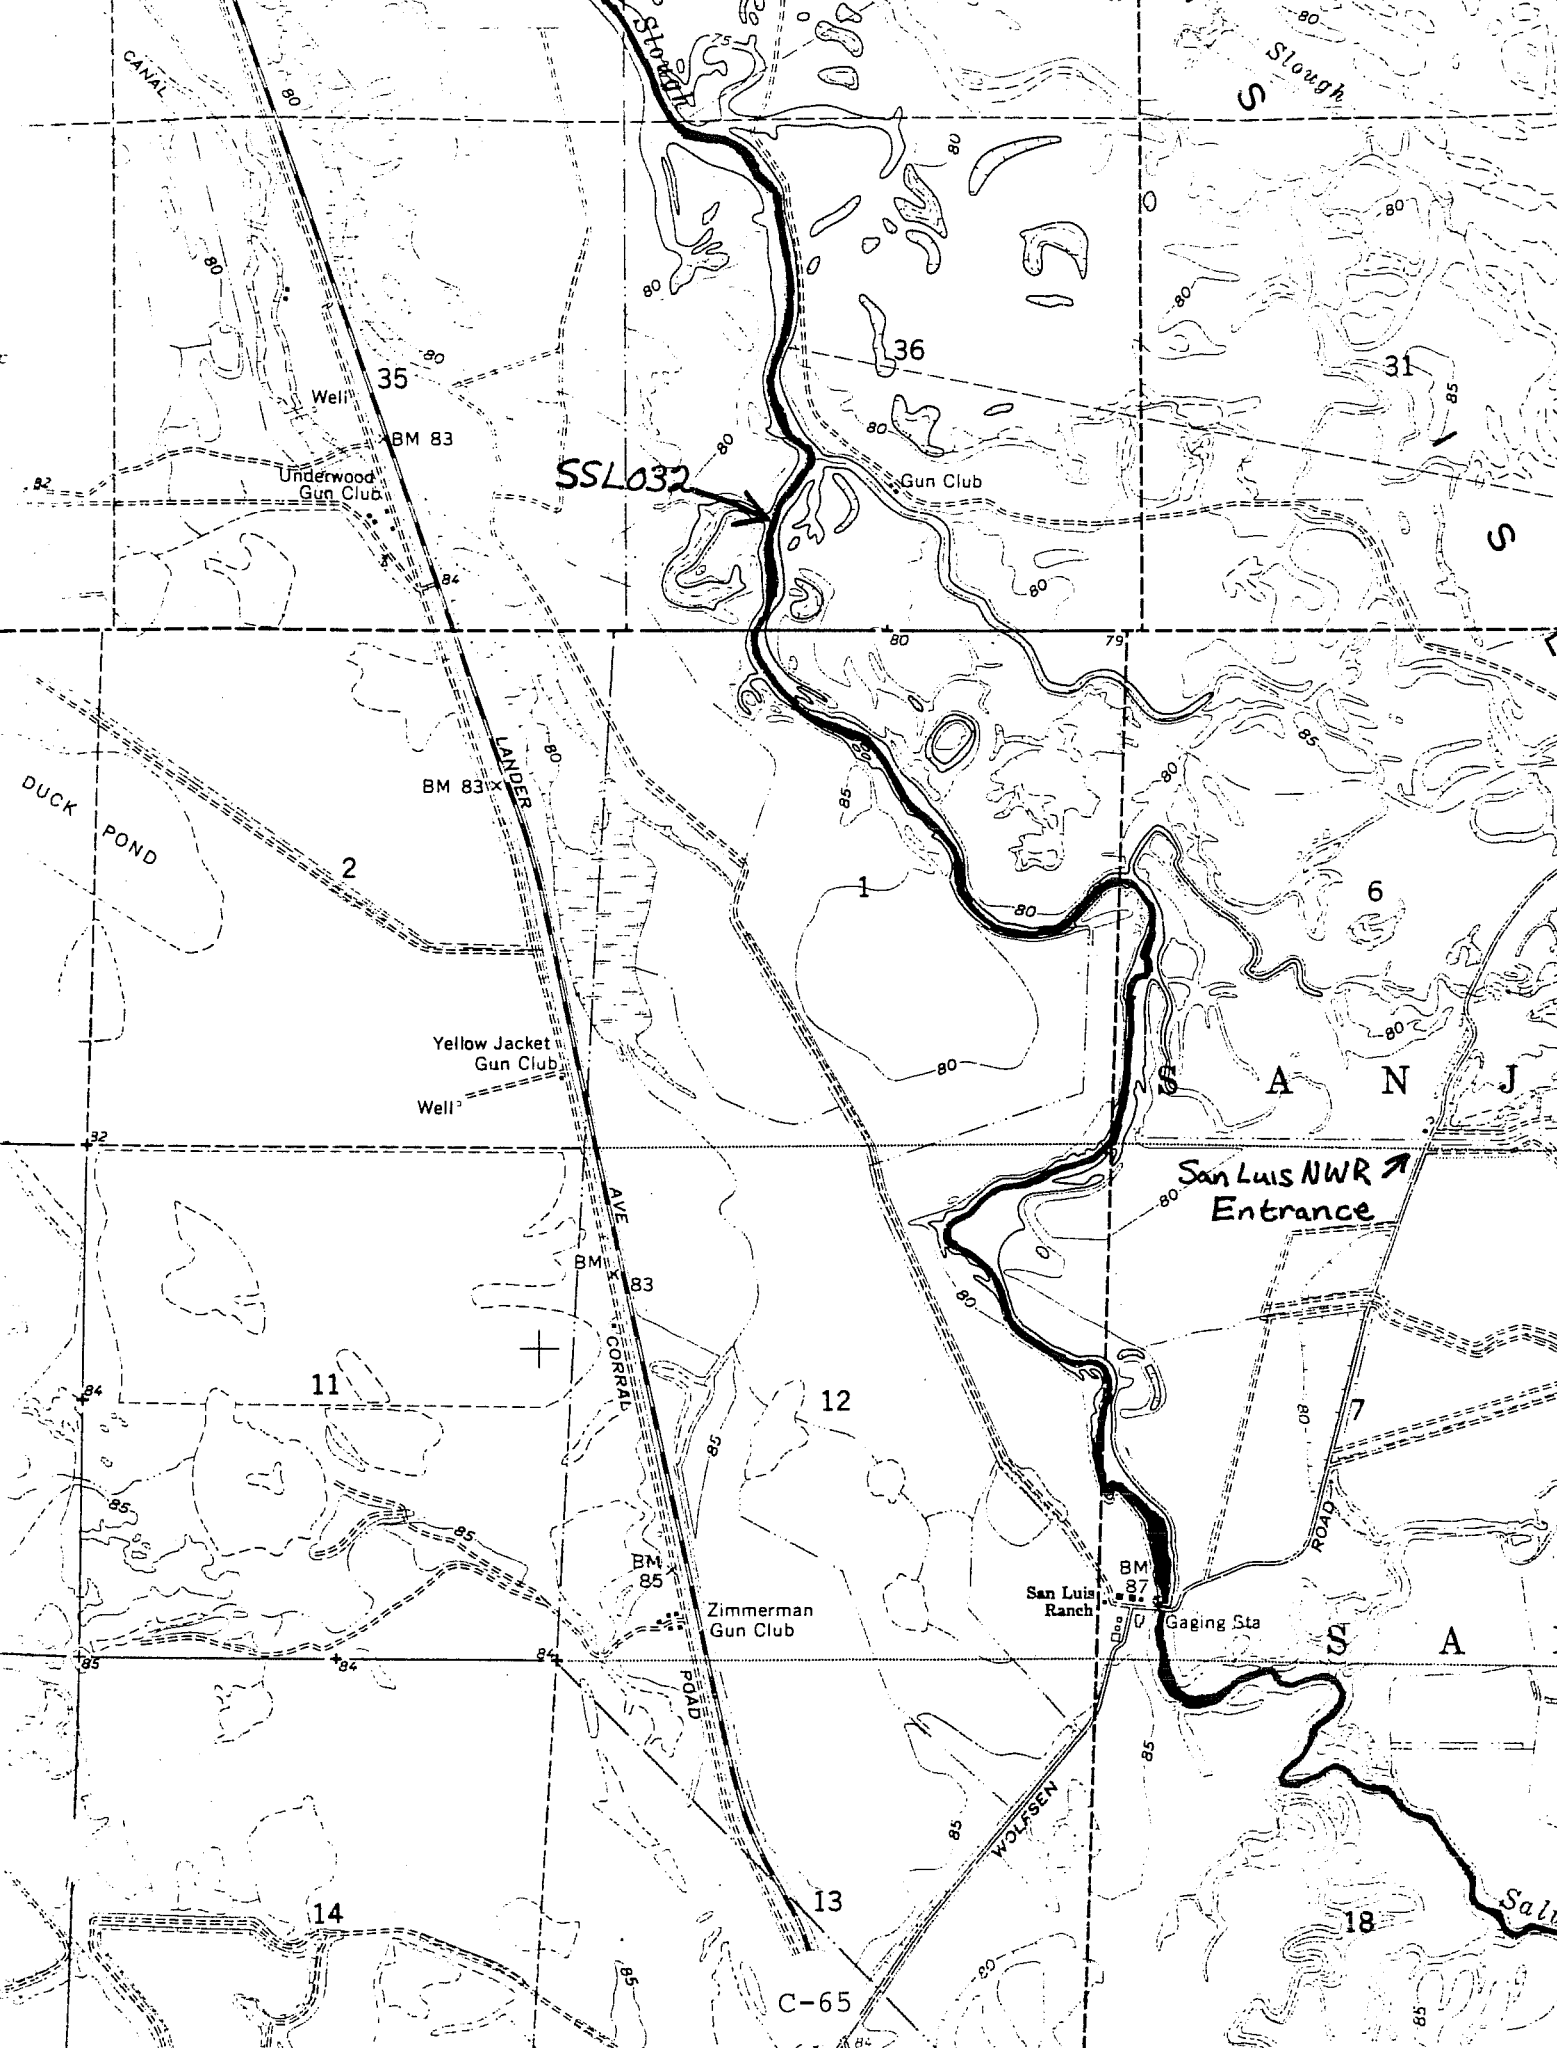
**SITE ID #SSL032**

**Site description, location, and access:** From Los Banos take Mercy Springs Road north for approximately 6.5 miles to Wolfsen Road. Proceed northeast on Wolfsen Road for approximately 2.1 miles to the entrance of the San Luis National Wildlife Refuge. At this point, you will have just passed over a large canal. Follow this canal west, along the north side, to Salt Slough. From here, proceed north for 1.87 miles to where a large channel enters the Slough from its west bank. This is the discharge site.

**Type and source of water being discharged (description):** This drain drains a fairly large area of pastureland to the west of Salt Slough.

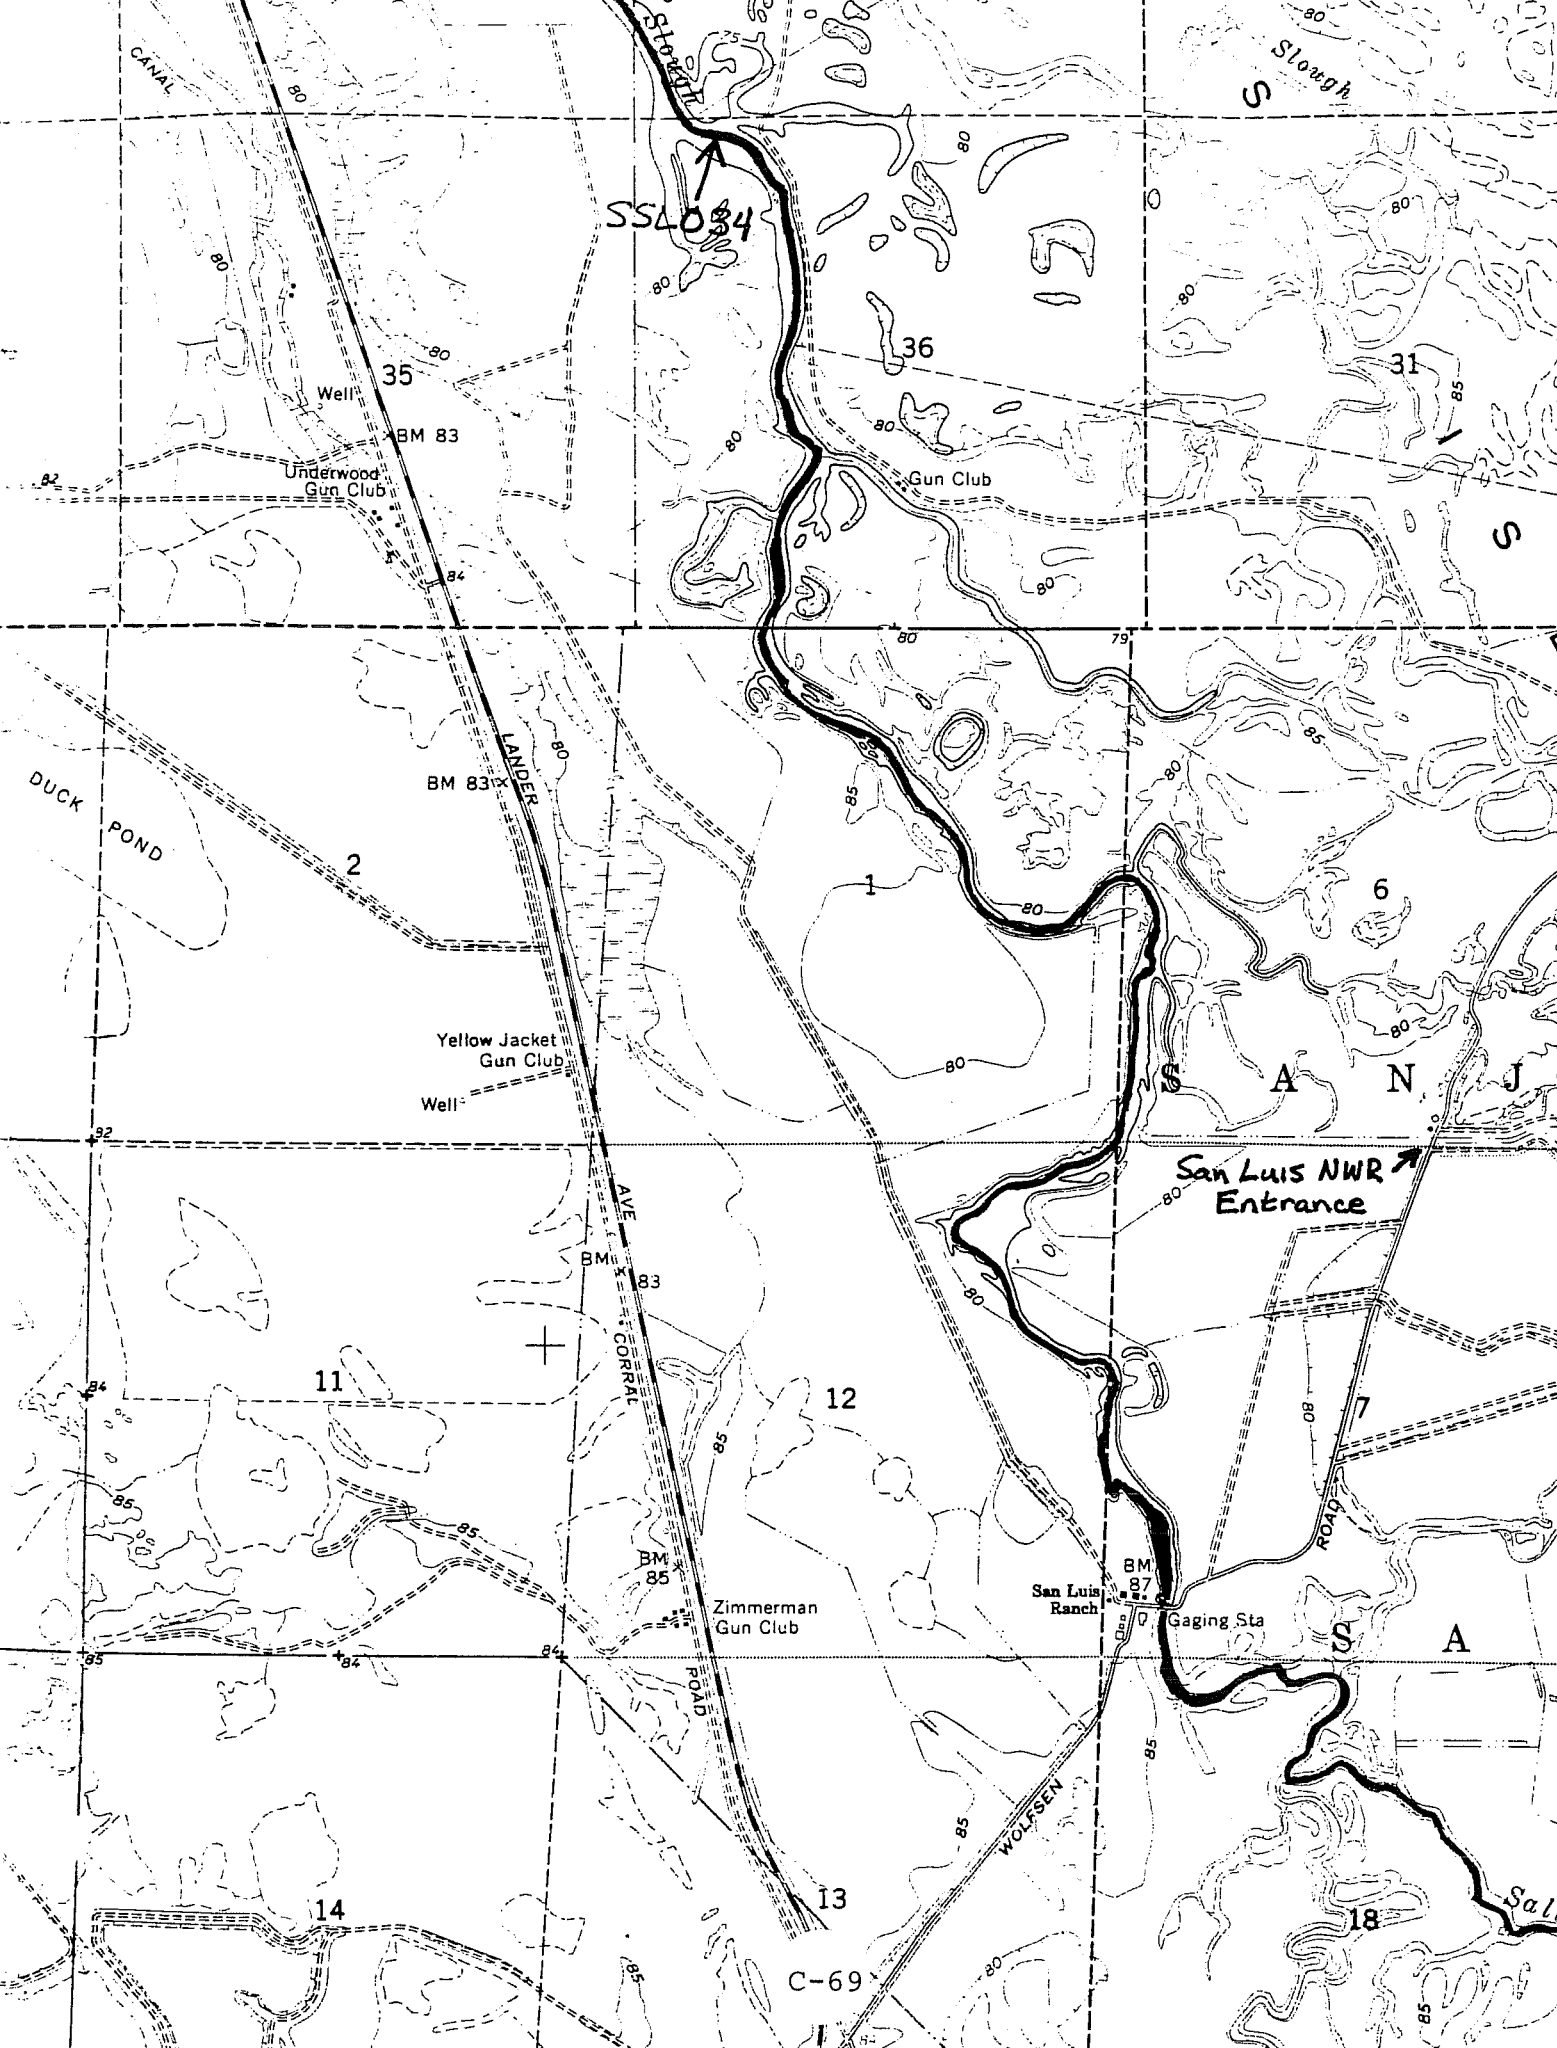
**SITE ID #SSL034**

**Site description, location, and access:** From Los Banos take Mercy Springs Road north for approximately 6.5 miles to Wolfsen Road. Proceed northeast on Wolfsen Road for approximately 2.1 miles to the entrance of the San Luis National Wildlife Refuge. At this point, you will have just passed over a large canal. Follow this canal west, along the north side, to Salt Slough. From here, proceed north for 2.65 miles to where a corrugated pipe enters the Slough from the west bank. This is the discharge site.

**Type and source of water being discharged (description):** Water discharged at this point is drainage from pastureland just to the west of Salt Slough.

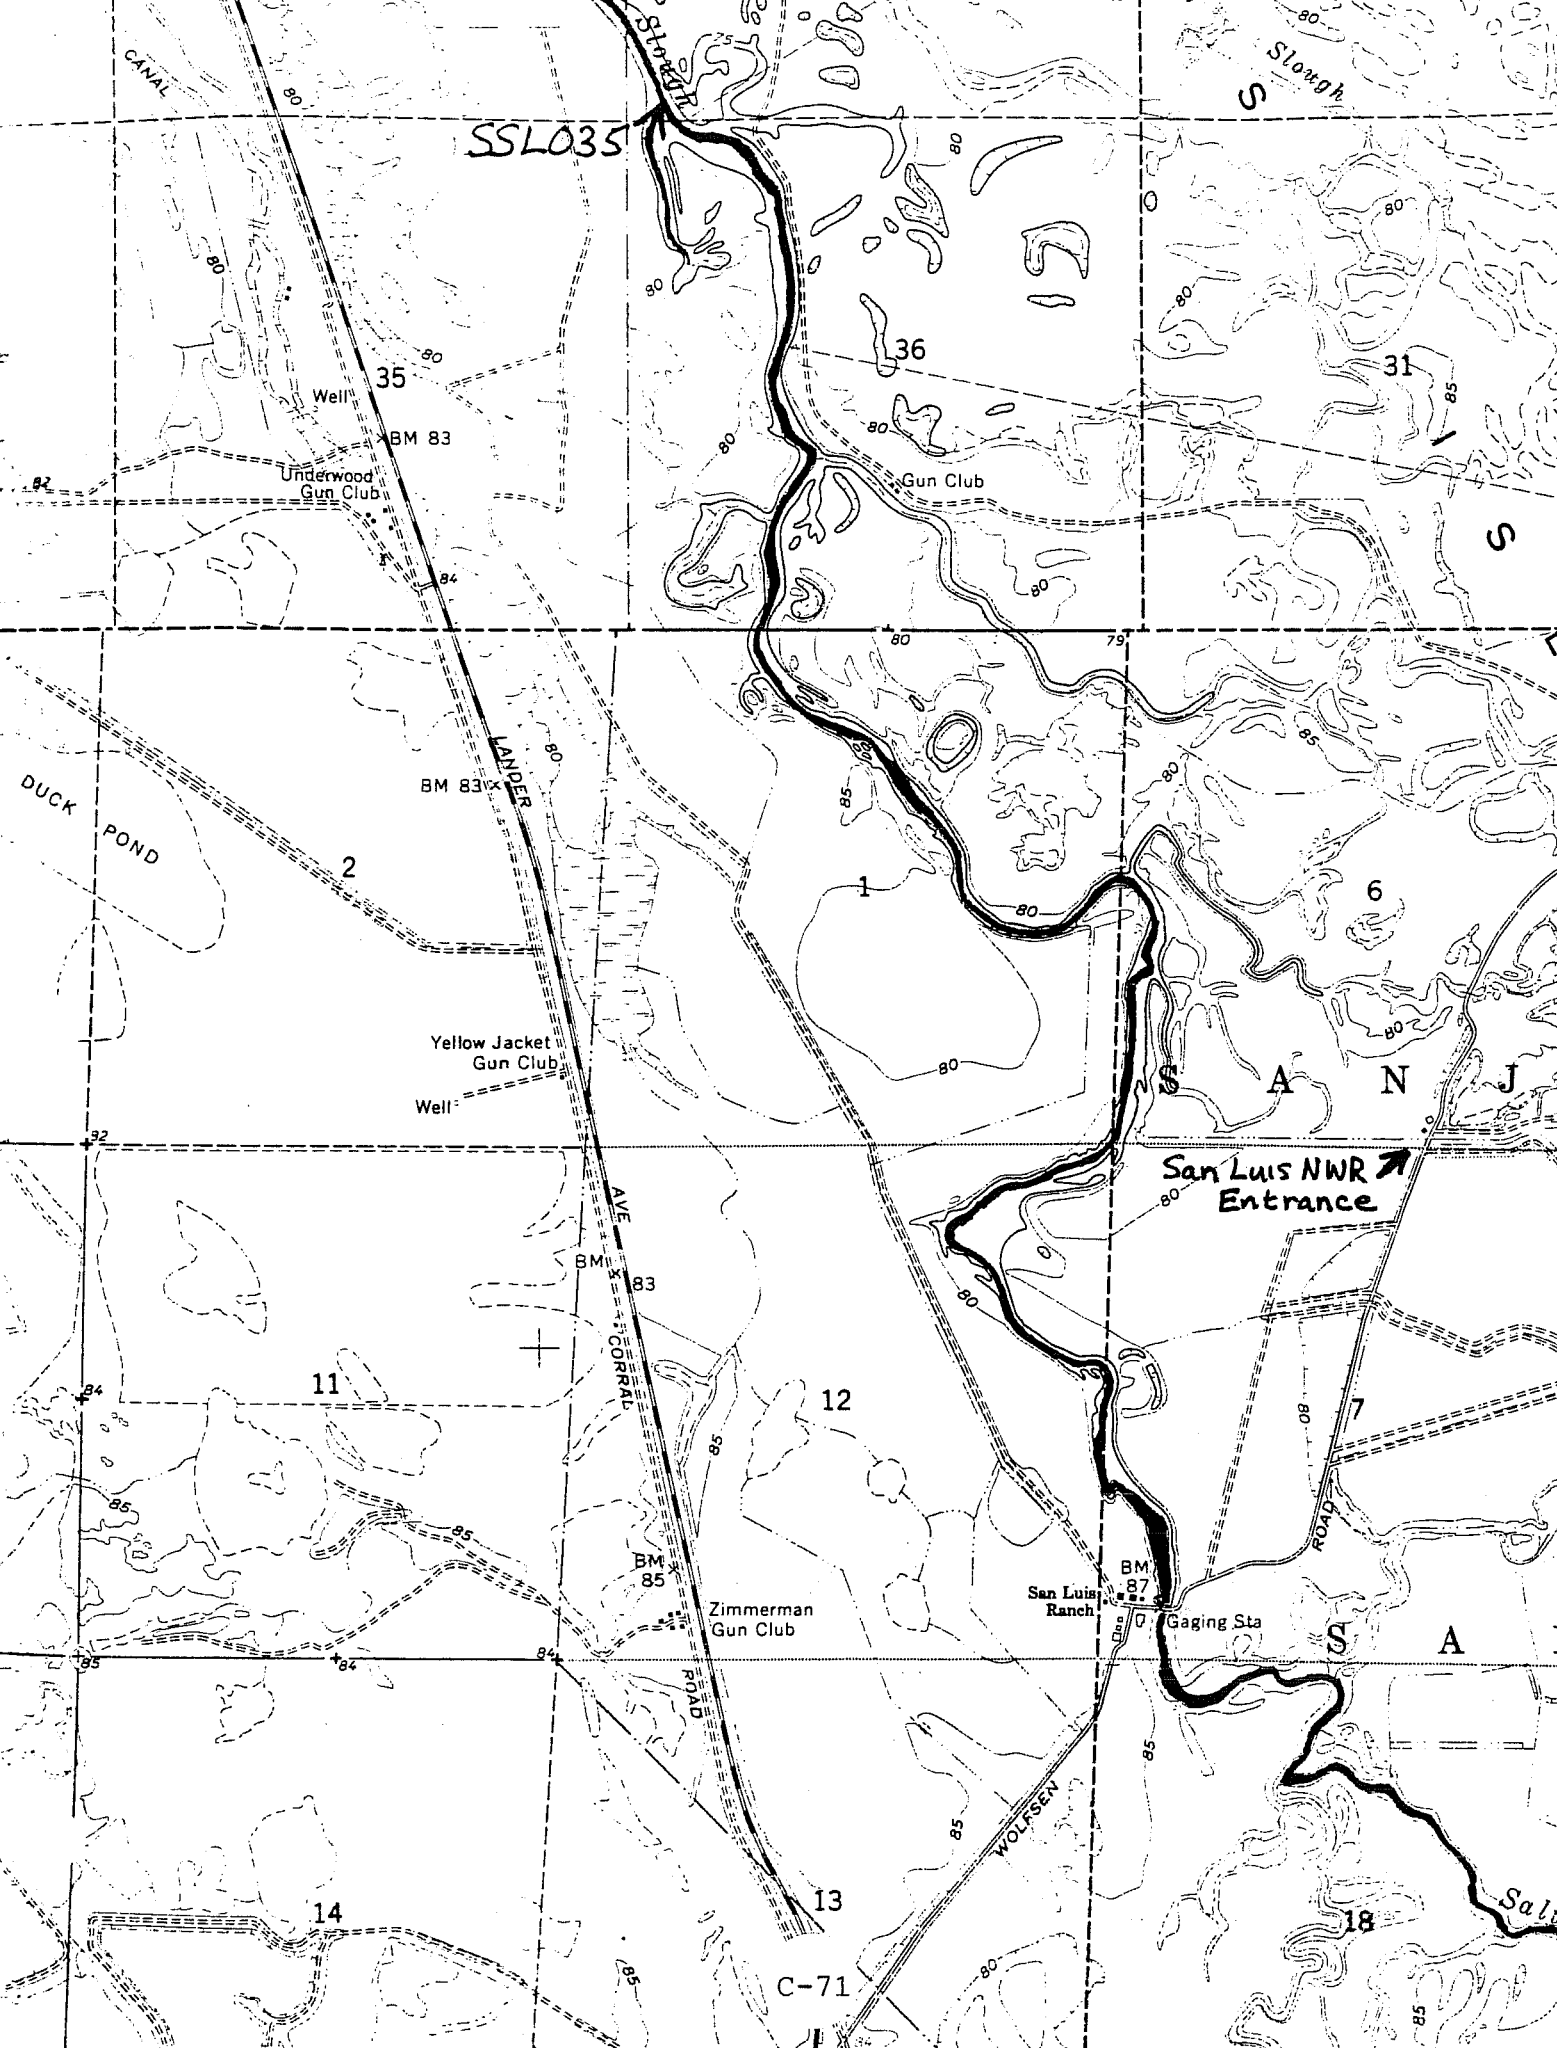
**SITE ID #SSL035**

**Site description, location, and access:** From Los Banos take Mercy Springs Road north for approximately 6.5 miles to Wolfsen Road. Proceed northeast on Wolfsen Road for approximately 2.1 miles to the entrance of the San Luis National Wildlife Refuge. At this point, you will have just passed over a large canal. Follow this canal west, along the north side, to Salt Slough. From here, proceed north for 2.75 miles to where a large channel enters from the west bank of the Slough. This is the discharge site.

**Type and source of water being discharged (description):** This drain drains a number of small ponds to the southwest of Salt Slough.

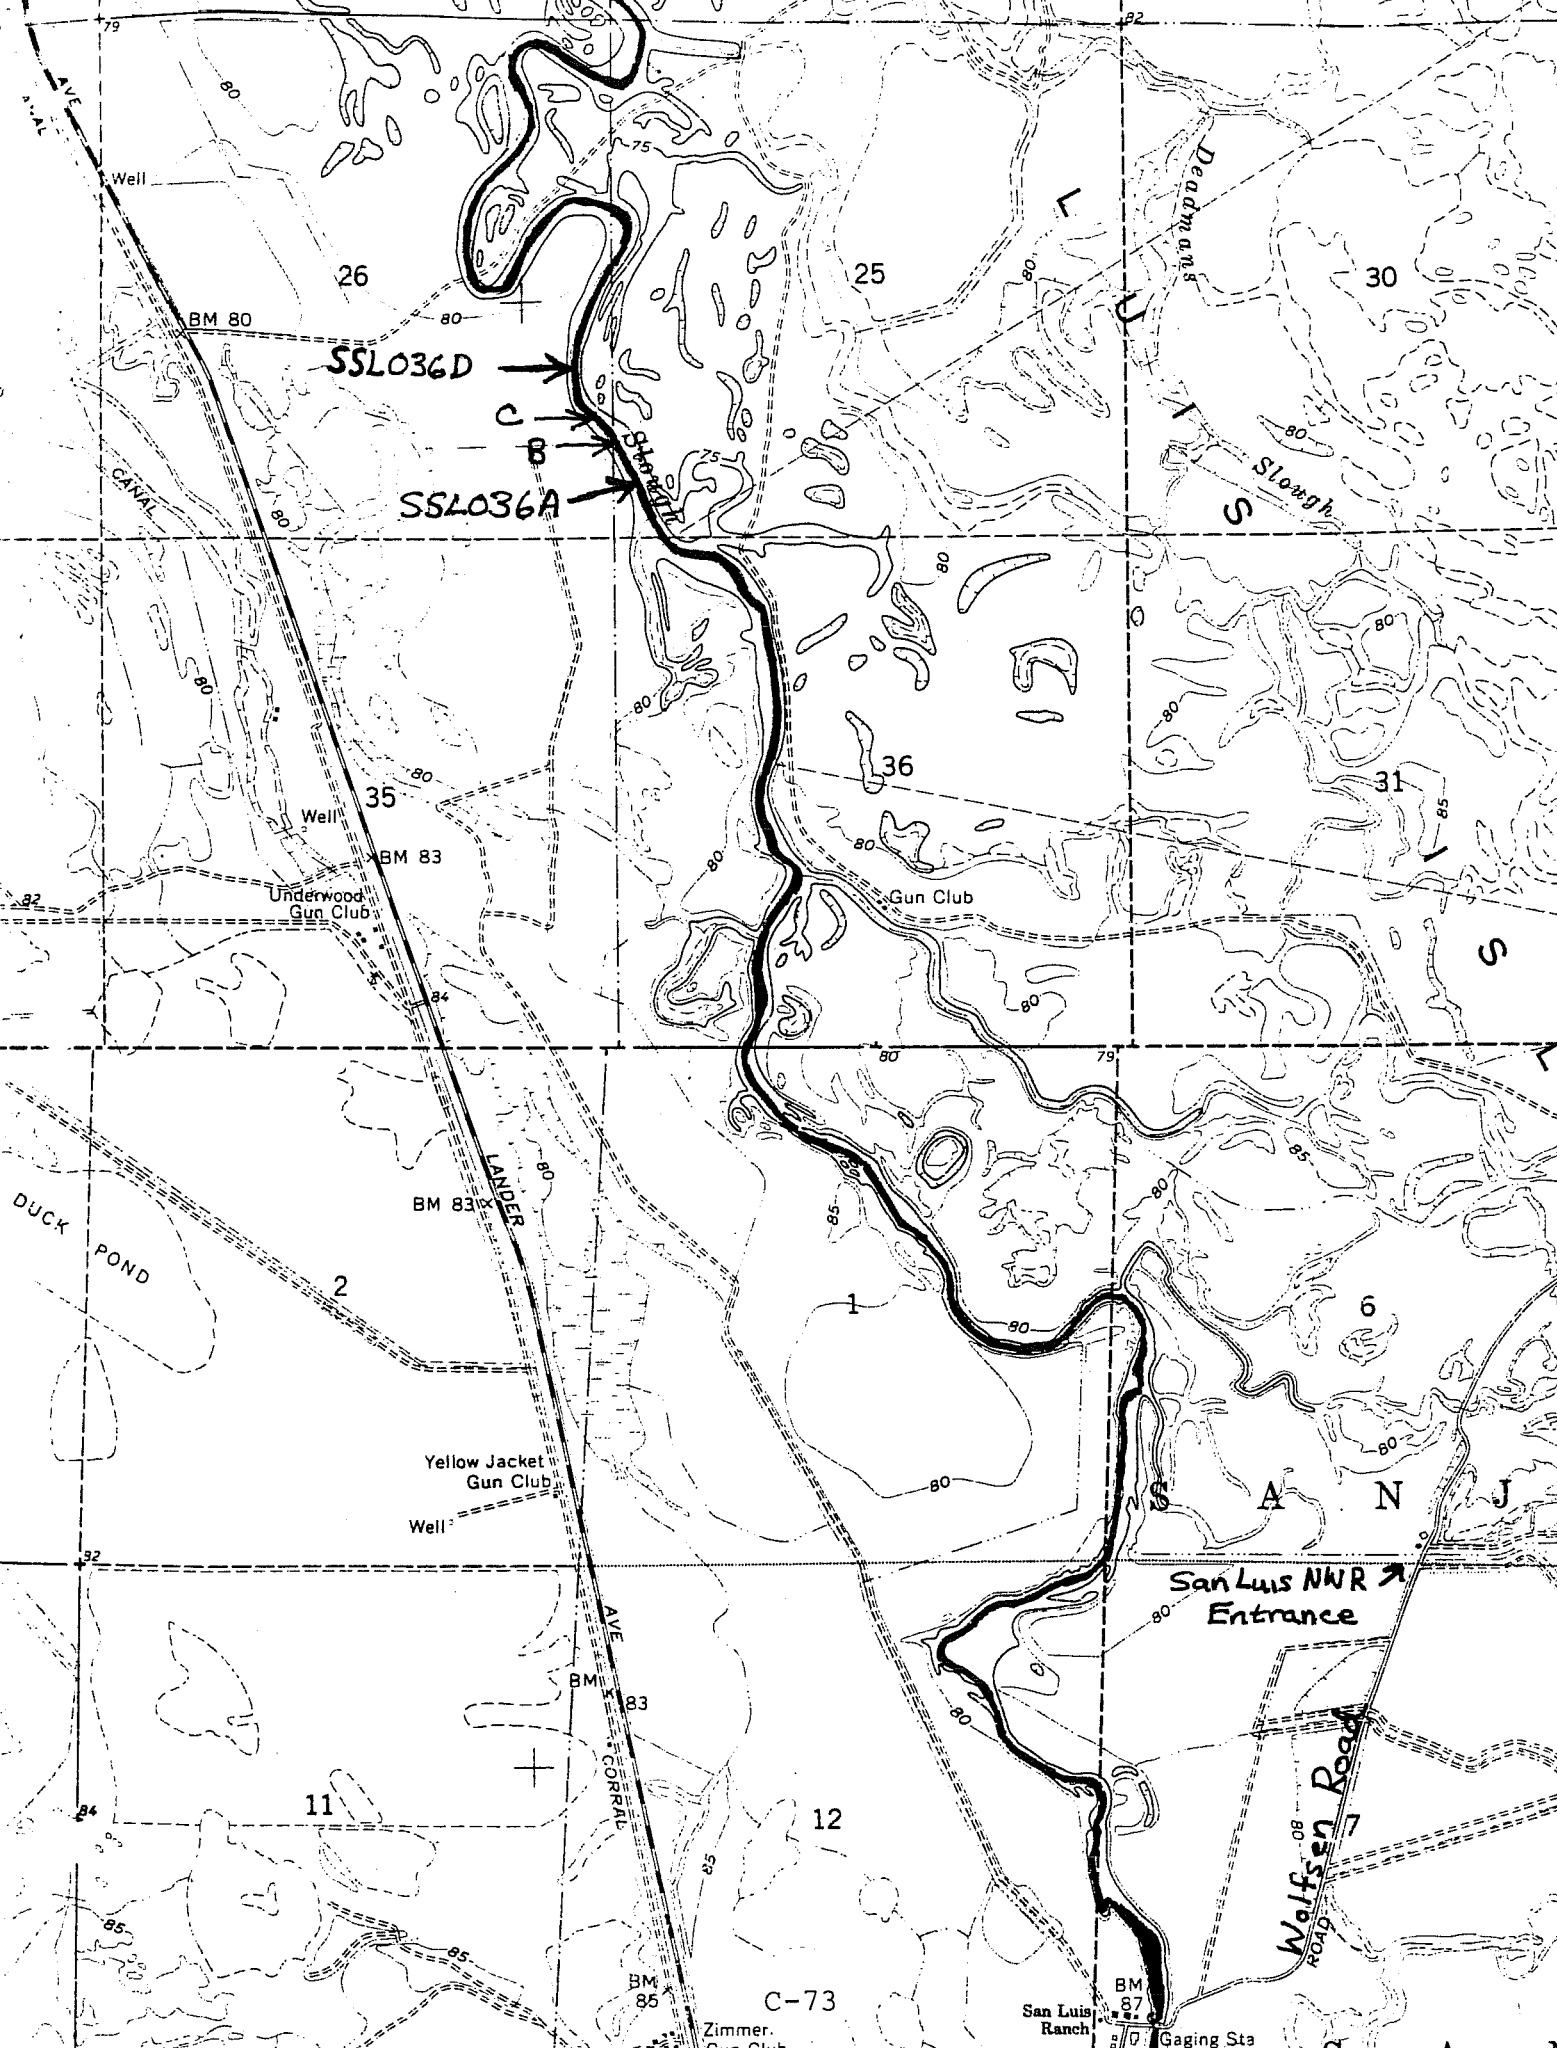
**SITE ID #SSL036A-D**

**Site description, location, and access:** From Los Banos take Mercy Springs Road north for approximately 6.5 miles to Wolfsen Road. Proceed northeast on Wolfsen Road for approximately 2.1 miles to the entrance of the San Luis National Wildlife Refuge. At this point, you will have just passed over a large canal. Follow this canal west, along the north side, to Salt Slough. From here, proceed north for 2.85 miles to where a corrugated pipe enters the Slough from the west bank. This is site SSL036A.

**Type and source of water being discharged (description):** Each of these drains drain small areas of pastureland just to the west of Salt Slough.

<u>Site #</u>	<u>Slough Mileage</u>	<u>Site Description</u>
SSL036A	9.21W	Small corrugated pipe entering the Slough from the west bank.
SSL036B	9.36W	Corrugated pipe entering the Slough from the west bank 0.15 miles north of SSL036A.
SSL036C	9.41W	Pipe entering the Slough from the west bank; 0.20 miles north of SSL036A.
SSL036D	9.56W	Corrugated pipe entering the Slough from the west bank; 0.35 miles north of SSL036A.
